PIC18F2455/2550/4455/4550

PIC18F2455/2550/4455/4550 Rev. A3 Silicon Errata

The following silicon errata apply only to PIC18F2455/2550/4455/4550 devices with these Device/Revision IDs:

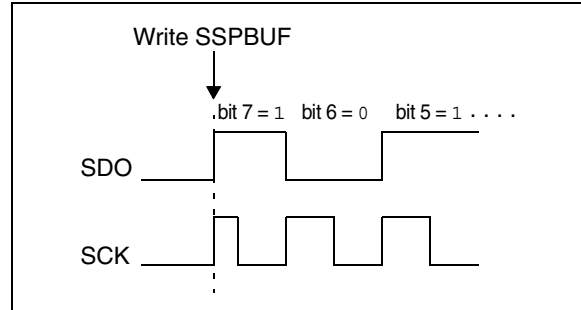
FIGURE 1: SCK PULSE VARIATION USING TIMER2/2

When the SPI is using Timer2/2 as the clock source, a shorter than expected SCK pulse may occur on the first bit of the transmitted/received data (Figure 1).

To avoid producing the short pulse, turn off Timer2 and clear the TMR2 register, load the SSPBUF with the data to transmit and then turn Timer2 back on. Refer to Example 6 for sample code.
